City of Gloversville

Schedule C

Downtown Urban Core Form-Based Overlay District: Illustrative Guide

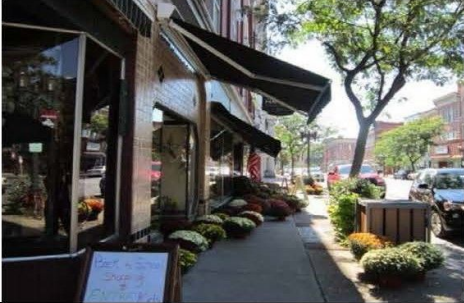
<p>Canvas-type awnings and canopies are encouraged.</p> <p>Shallow build-to-line supports a pedestrian-friendly street.</p> <p>Ground floor non-residential uses such as eating and drinking establishments, retail, service and offices with walk-in clientele are encouraged.</p>

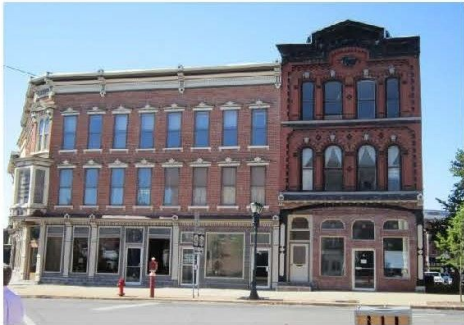
<p>The historic top floor cornice feature provides architectural interest.</p> <p>Primary window proportions are greater in height than in width.</p> <p>Storefront and second-story cornice provides horizontal architectural articulation.</p>

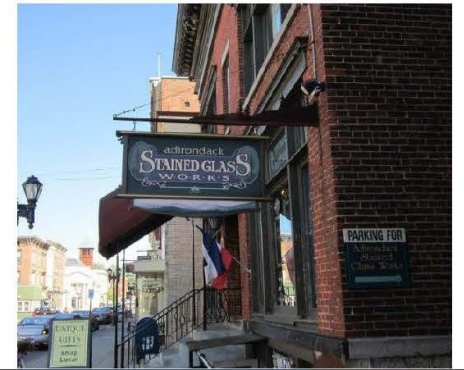
<p>Shingle signage and lighting are historically appropriate.</p> <p>Front entrance door faces the primary street and is connected to the sidewalk with a canopy-covered stoop providing weather protection for customers.</p> <p>Open porches, stoops, bay windows, balconies and other similar building features may encroach over the sidewalk.</p>

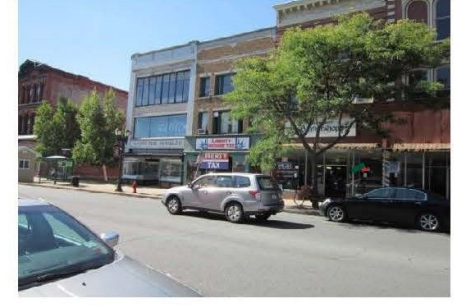
<p>Buildings incorporate breaks in the facades and rooflines at intervals of no more than 35 feet. Facades are broken up through the use of windows, recessed or protruding doorways, canopies, and other architectural treatments.</p> <p>Front entrance doors/retail storefronts are accentuated and attractive to customers.</p>

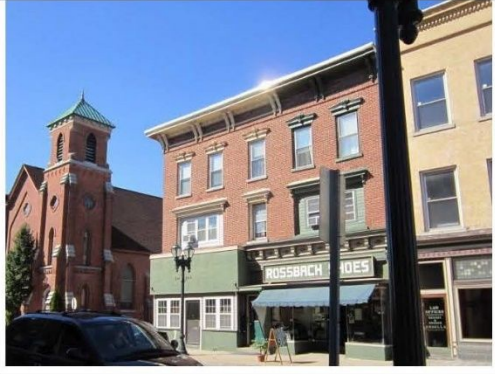
<p>Façade alteration is inconsistent with surrounding historic buildings. Storefront windows and doors should be cohesive in appearance and complimentary to the adjacent well-maintained historic façade.</p> <p>The second-story cornice is covered by the new façade treatment and the window and door replacements are not historically appropriate. When necessary, replacement windows should match the original windows in style, configuration and size, and storefronts should have a consistent and cohesive pattern.</p>

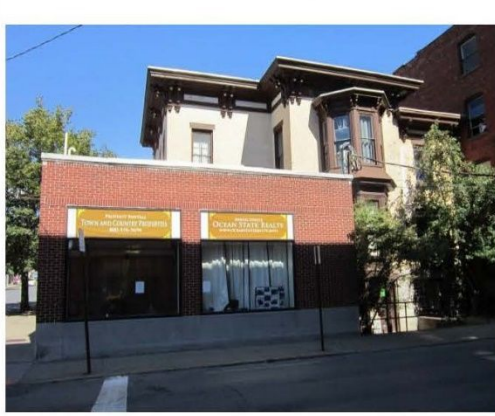
<p>The new addition neglects to consider the adjacent/attached historic structure, is proportionally out of scale, and interrupts the existing architectural rhythm of the street.</p> <p>Roof lacks historically appropriate decorative cornice or parapet.</p> <p>Windows lack historically appropriate architectural treatments</p>

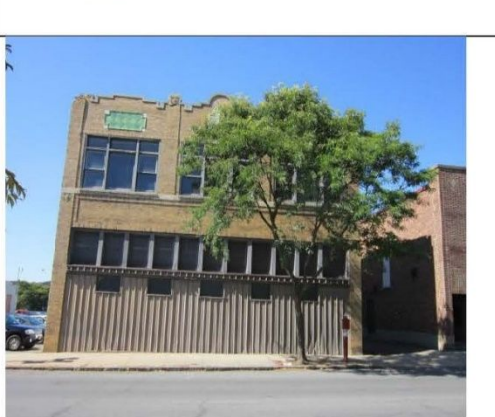
<p>The façade treatment covers the original doorways and windows.</p> <p>The primary building entrance should be accentuated.</p> <p>Galvanized metal siding should be permitted only as a roofing material. Blank facades without windows and/or doors should be discouraged on any exterior wall facing the public right-of-way.</p>

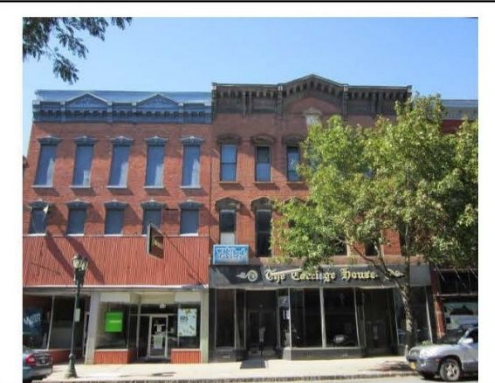
<p>Façade alterations should employ architectural detailing that is Compatible with the architecture of the adjacent buildings.</p> <p>Sign type and placement are incompatible with the character of the building.</p> <p>New façade covers a portion of the second-story windows, as well other important architectural details.</p>
