LAND USE AND DEVELOPMENT

L. S. Figures 1 through 5 and 7 and 8

Township of Hamilton

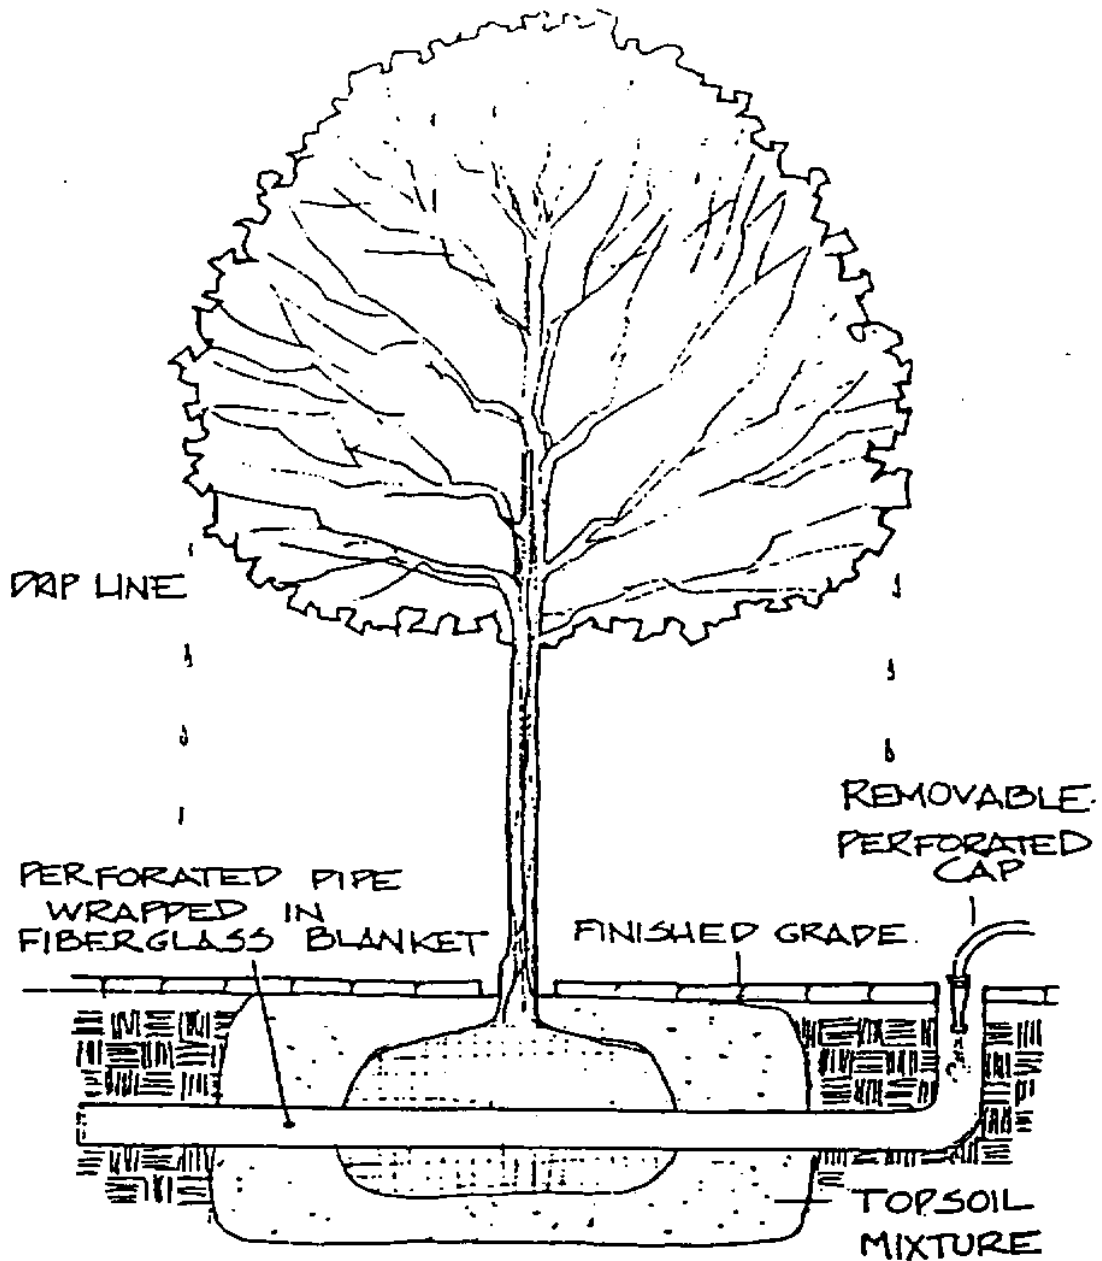
L.S. Figure 1. Tree in pavement.

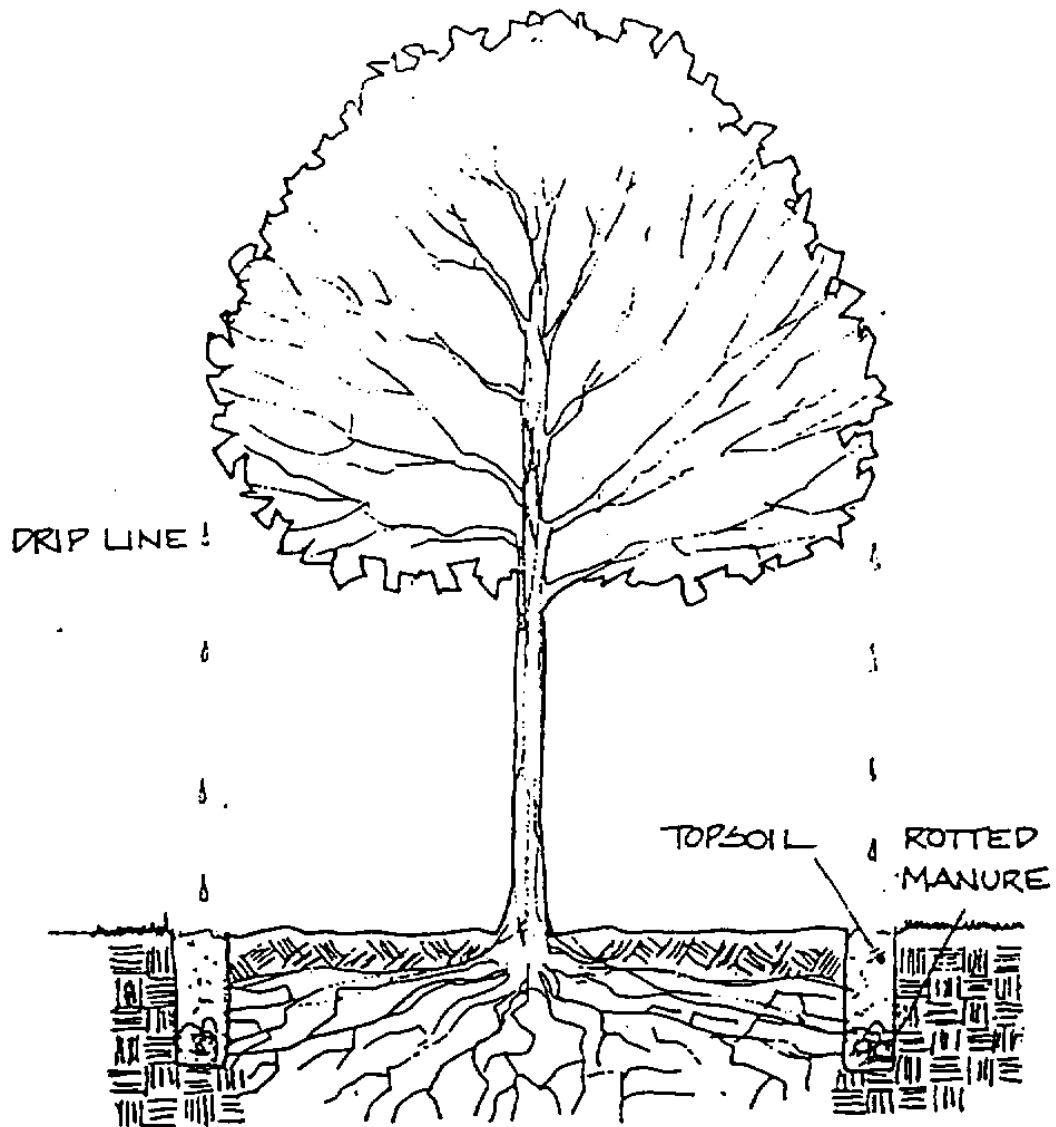
**L.S. Figure 2. Root pruning to induce fibrous root system
at a lower level.**

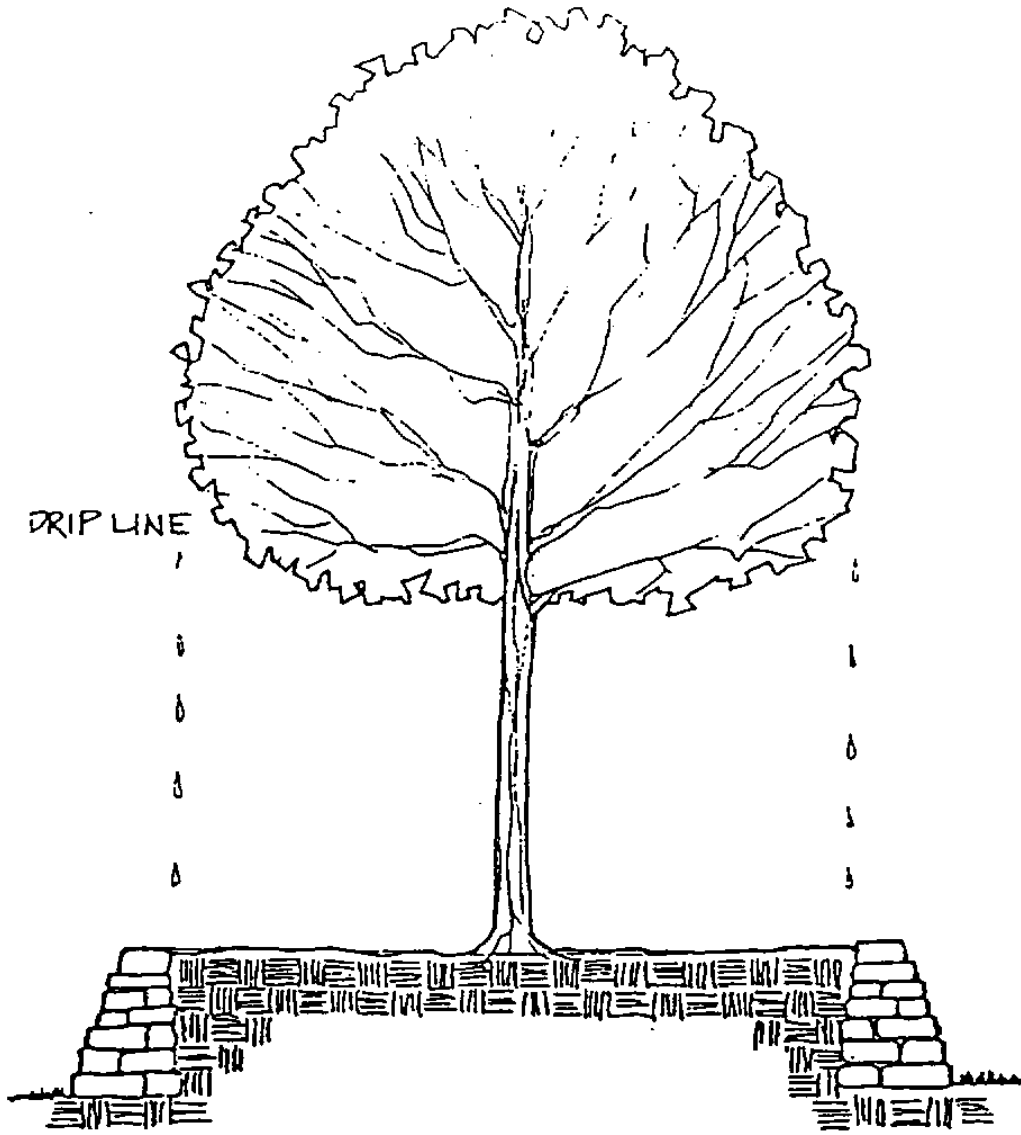
L.S. Figure 3. Existing tree in cut protected by retaining wall.

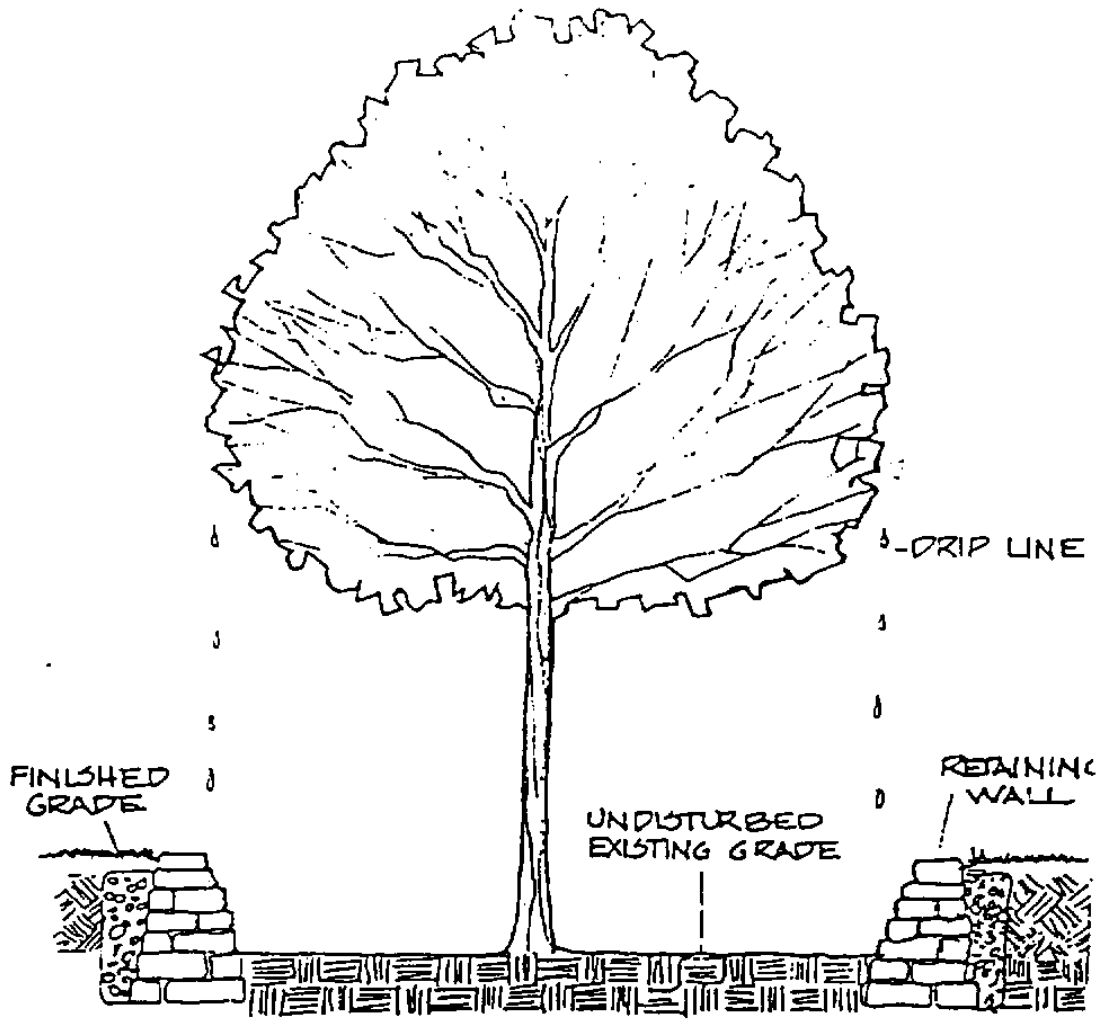
L.S. Figure 4. Existing tree in fill protected by a wall.

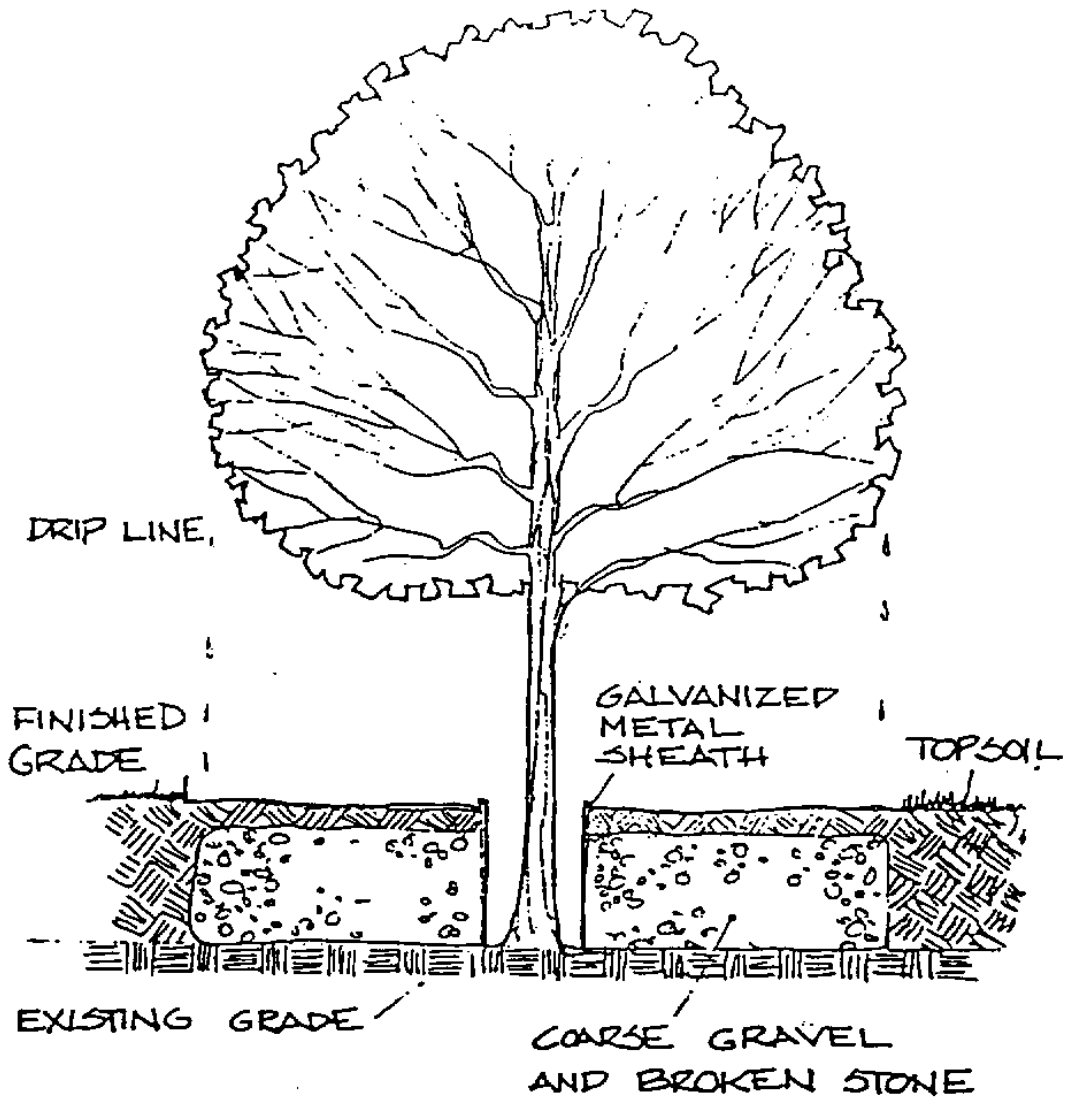
L.S. Figure 5. Existing tree in fill protected by coarse gravel.

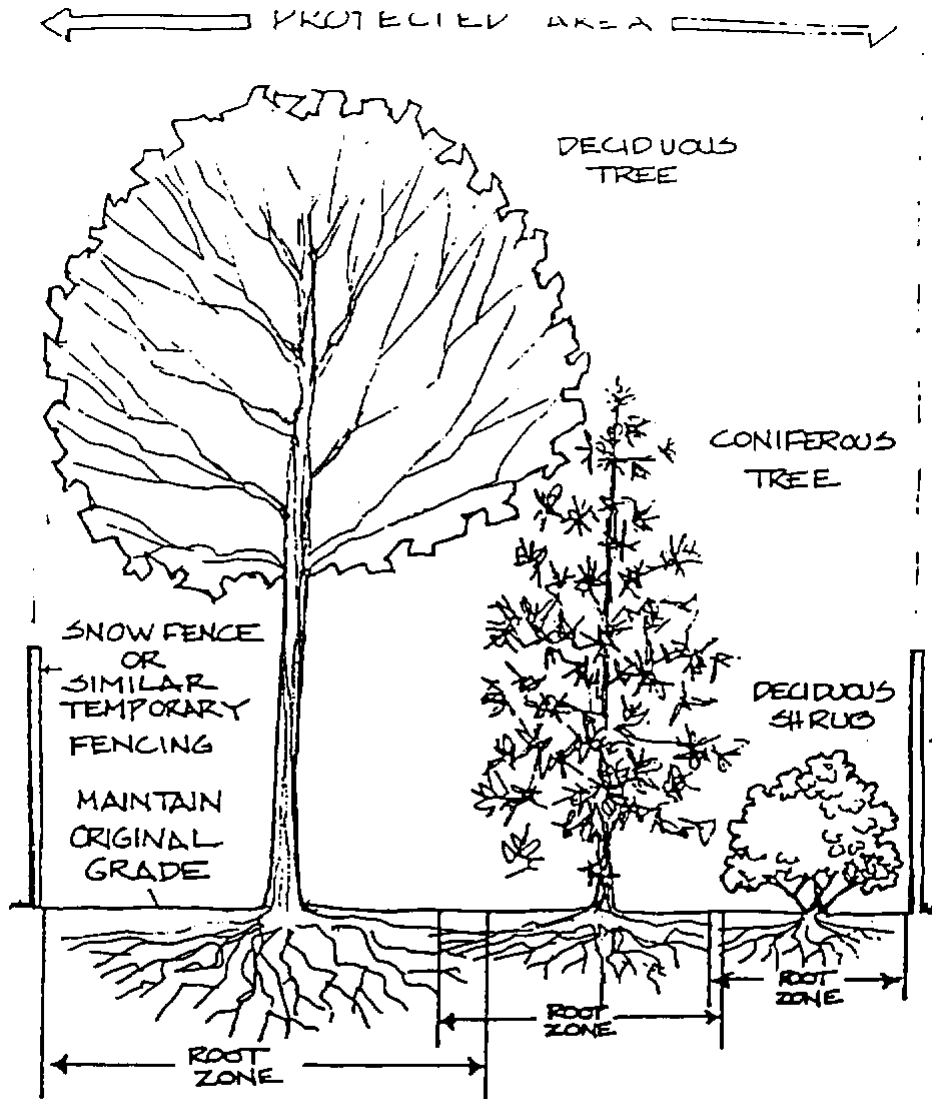
NO VEHICLES, EXCAVATION, FILL, WASTE, OR MATERIAL STORAGE SHOULD BE ALLOWED IN THIS ZONE.

L.S. Figure 7. Cross section of typical plant grouping.

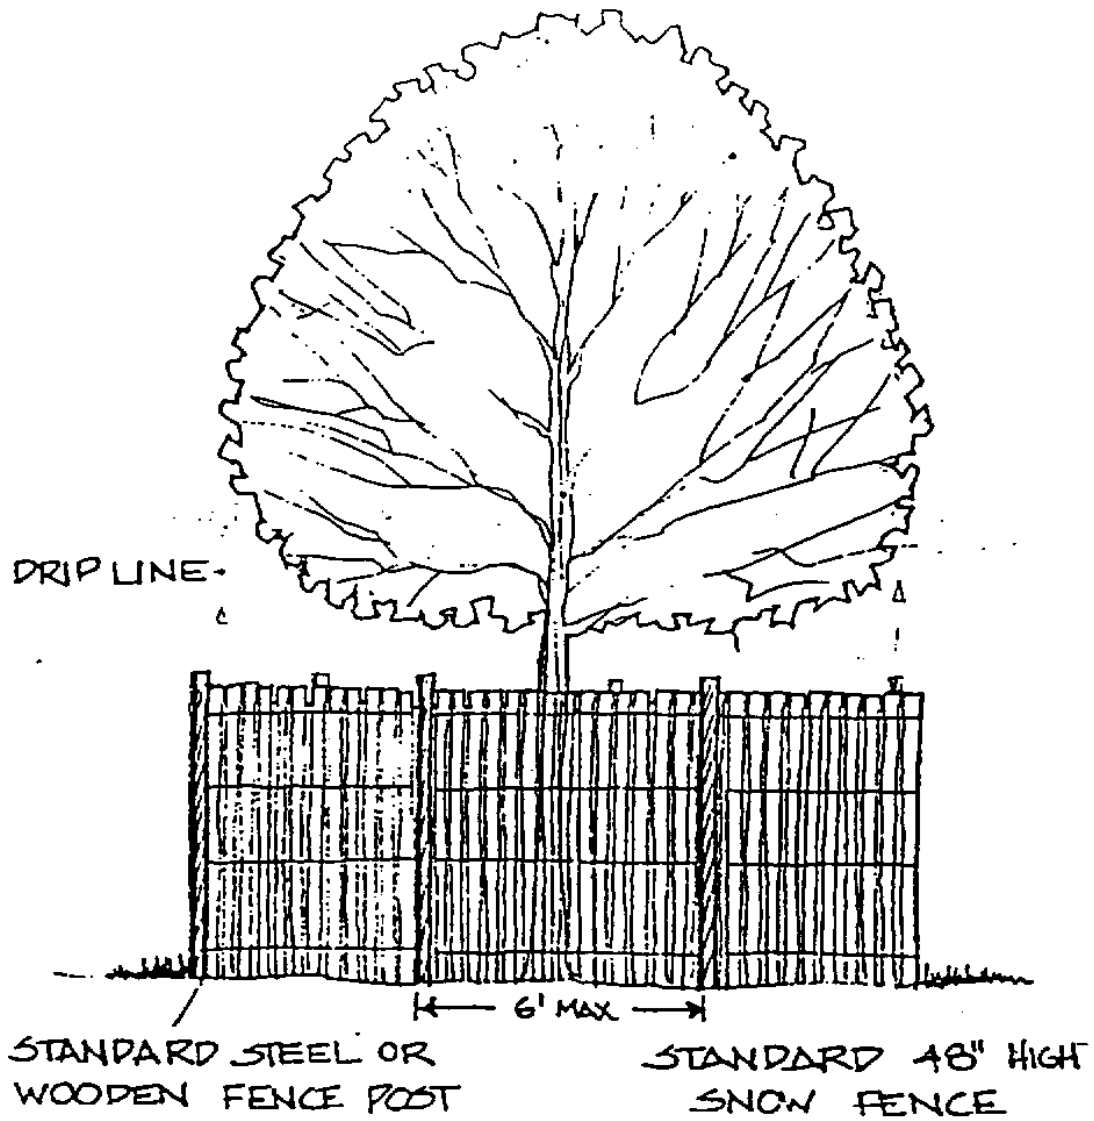
L.S. Figure 8. Existing tree protected by snow fence.
