# LAND USE AND DEVELOPMENT

L. S. Figures 1 through 5 and 7 and 8

**Township of Hamilton**

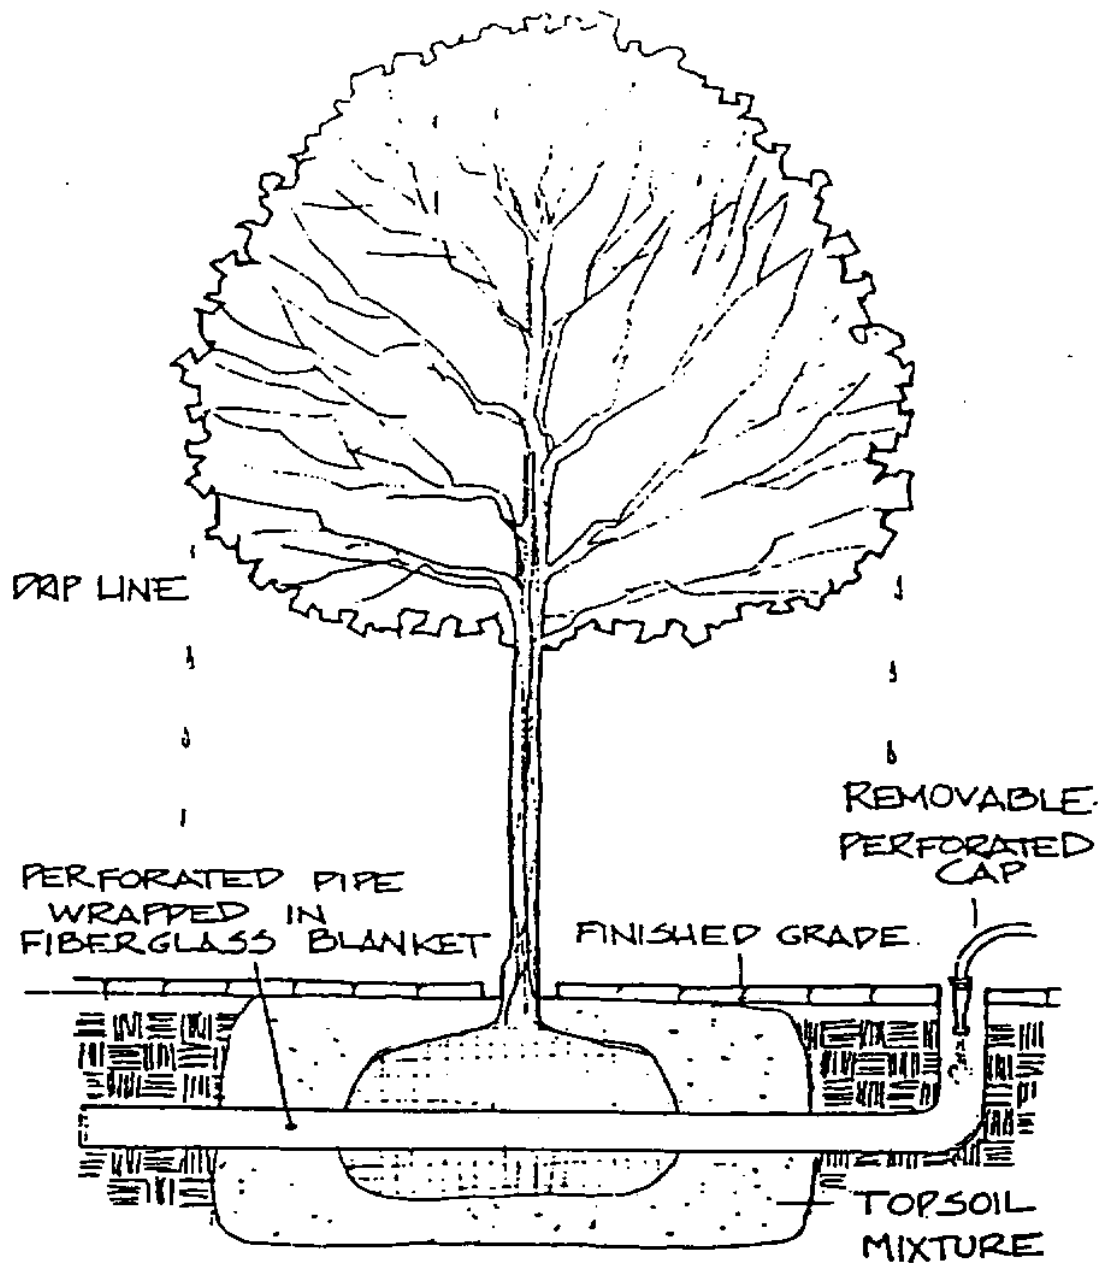
**L.S. Figure 1. Tree in pavement.**

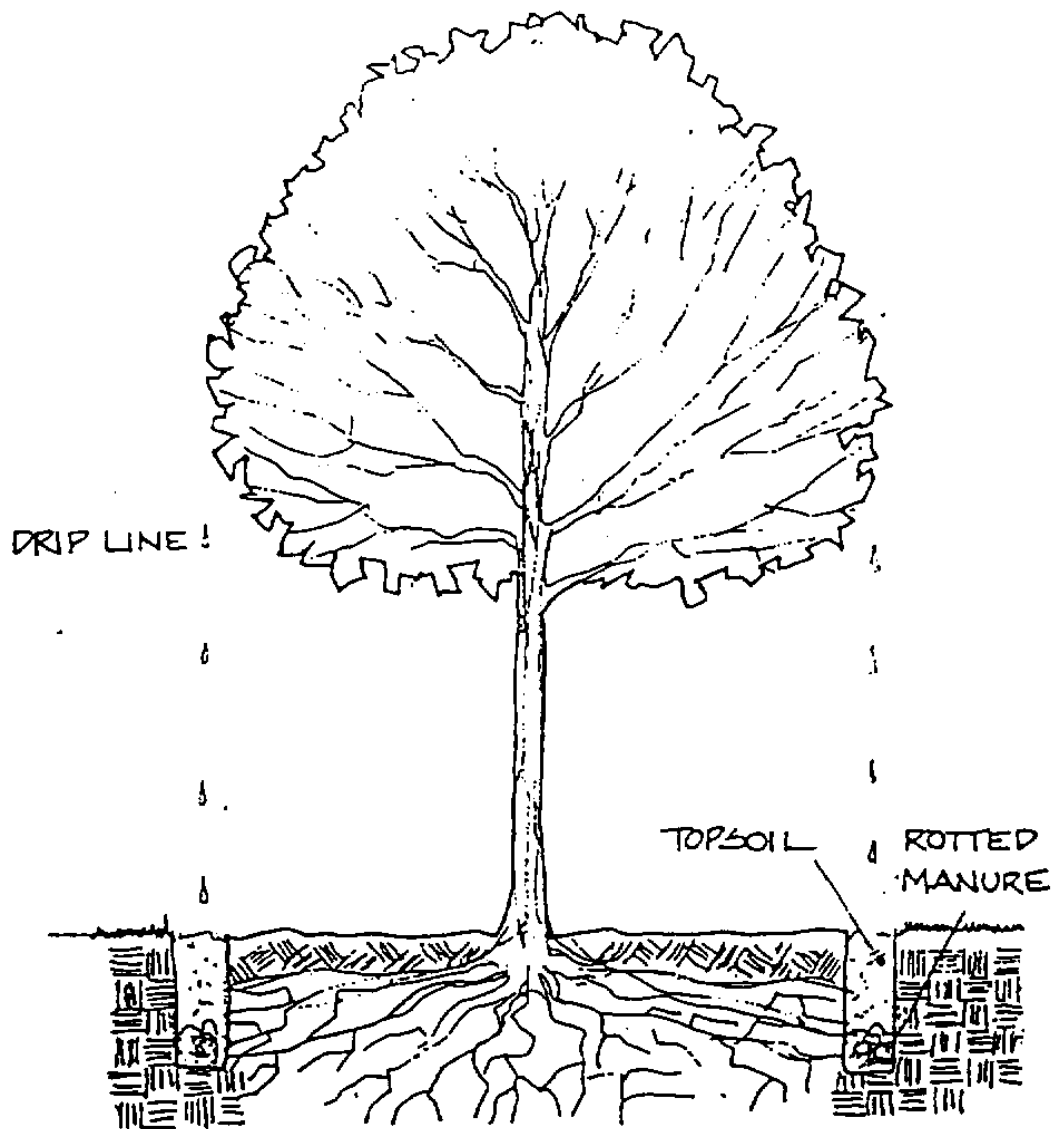
**L.S. Figure 2. Root pruning to induce fibrous root system  
at a lower level.**

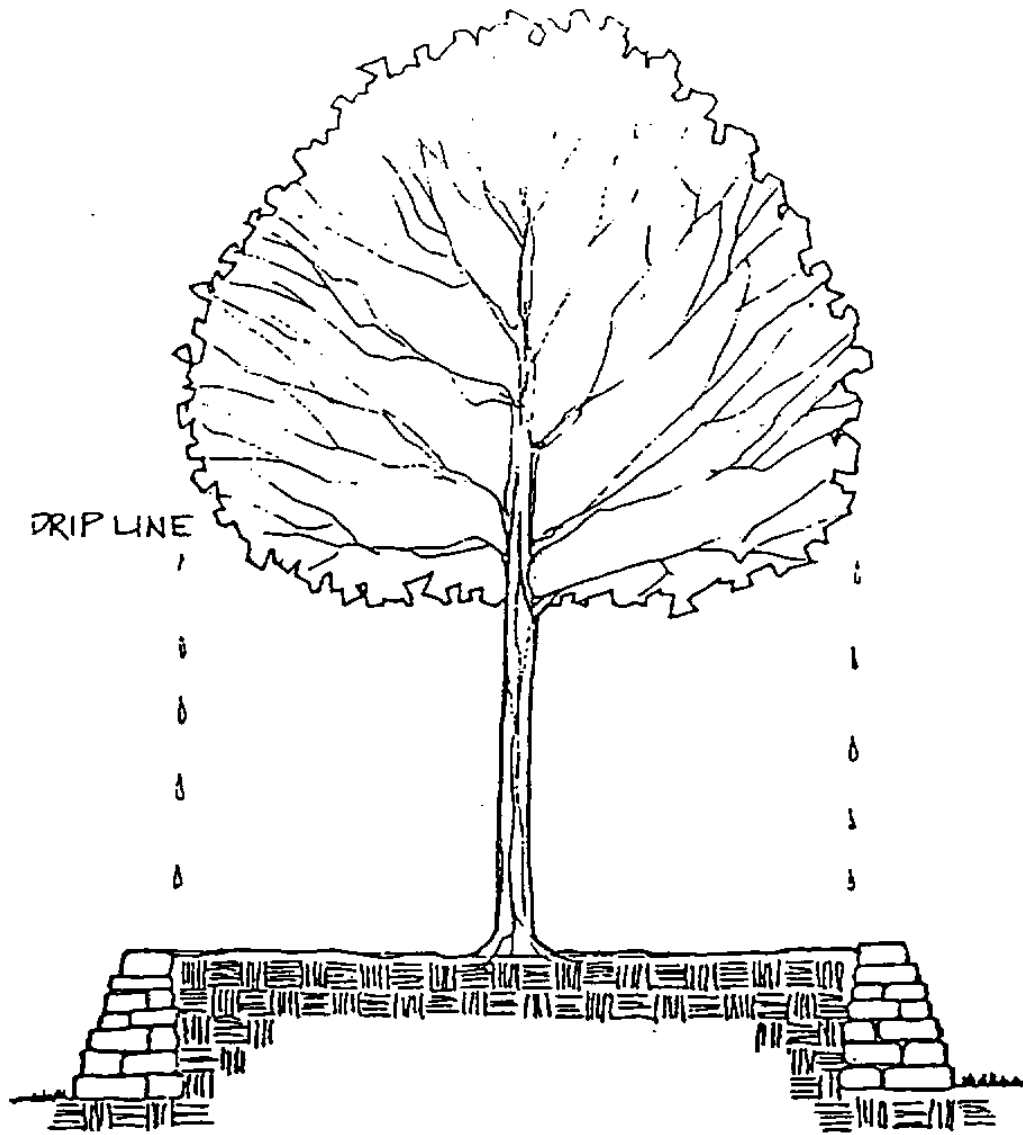
L.S. Figure 3. Existing tree in cut protected by retaining wall.

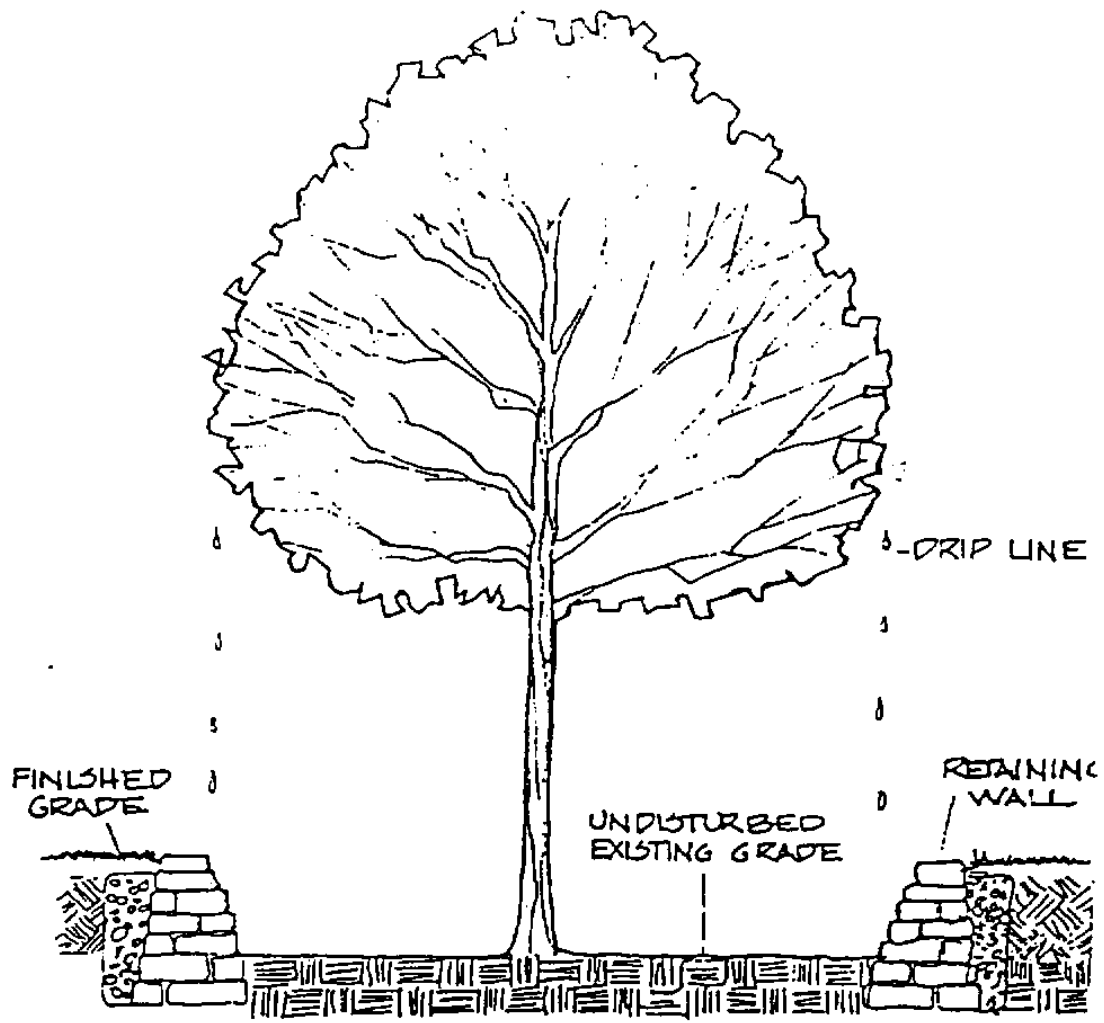
L.S. Figure 4. Existing tree in fill protected by a wall.

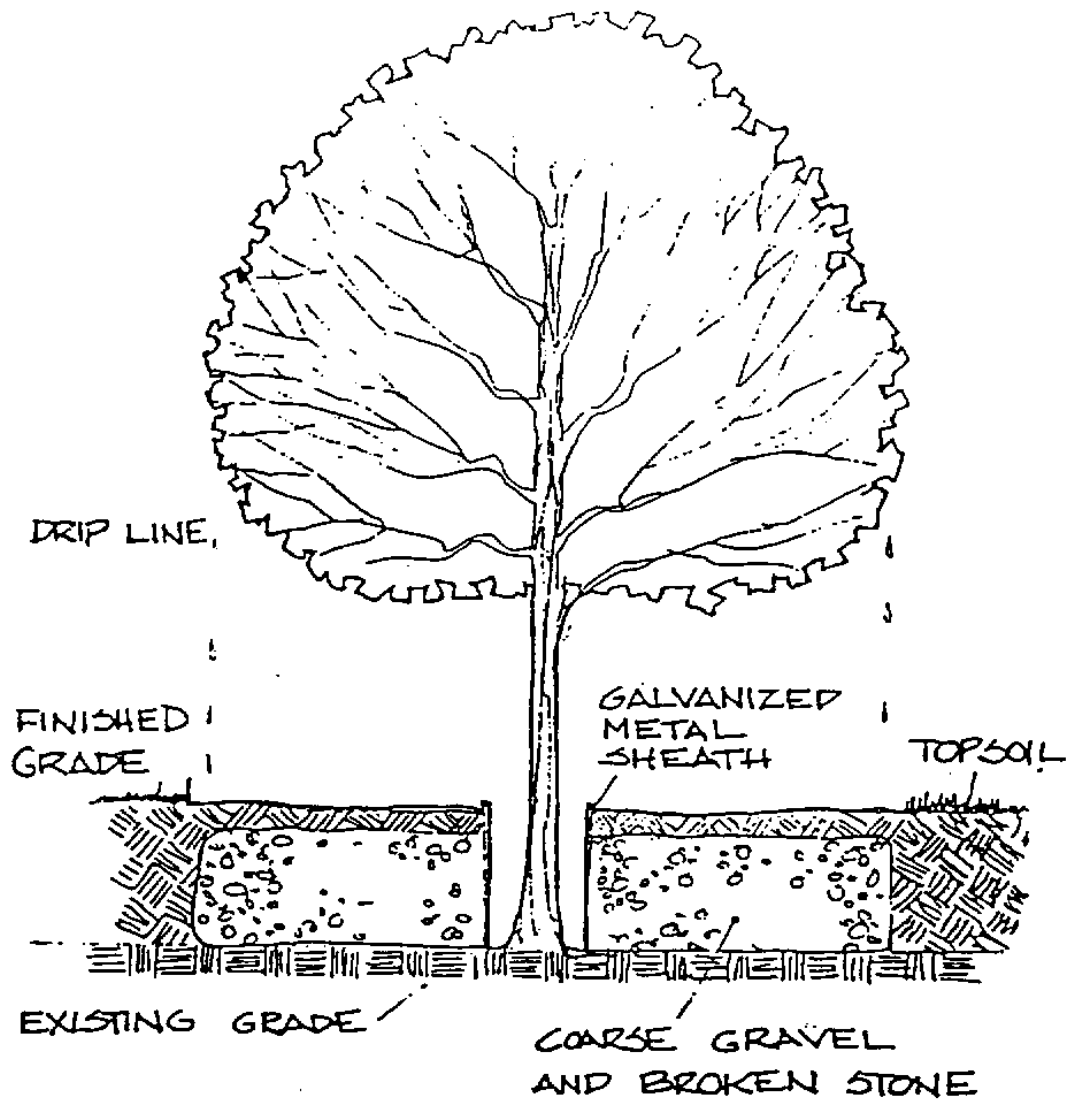
L.S. Figure 5. Existing tree in fill protected by coarse gravel.

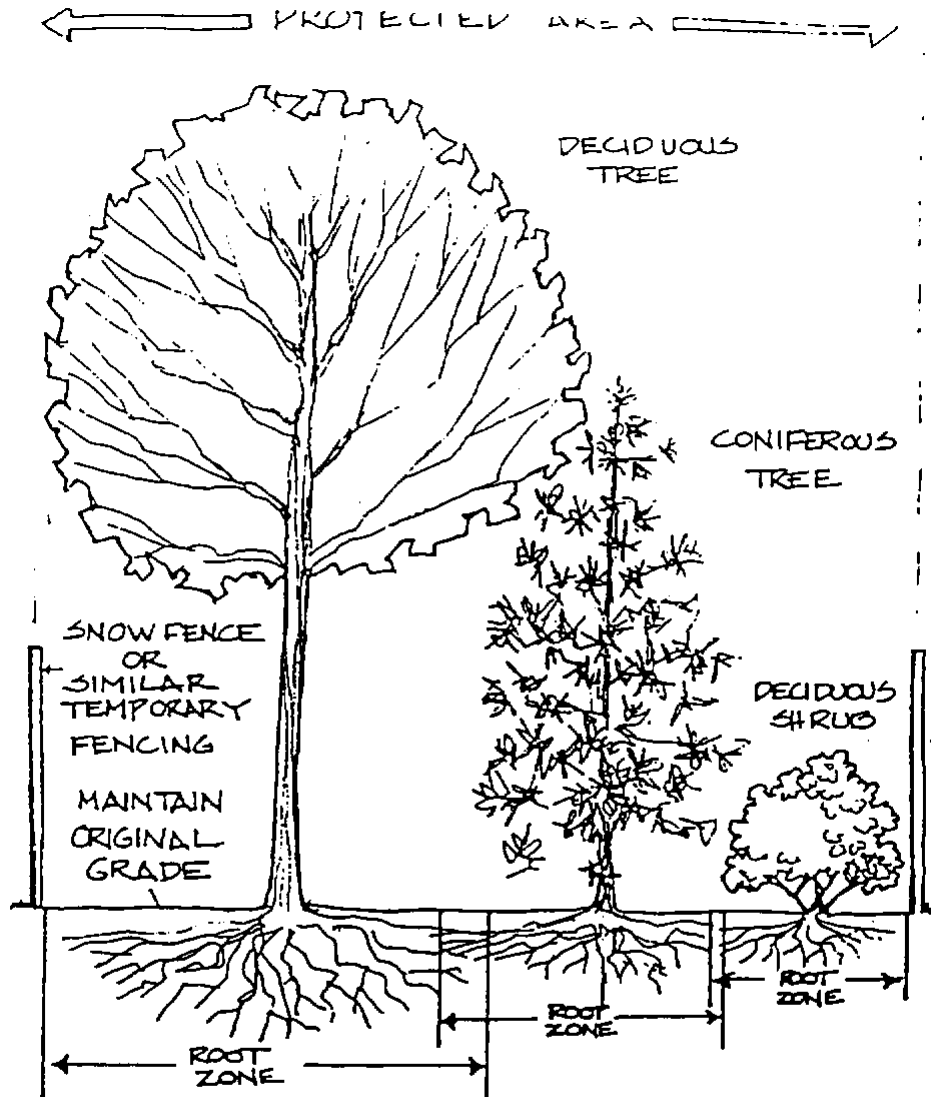
NO VEHICLES, EXCAVATION, FILL, WASTE, OR MATERIAL STORAGE SHOULD BE ALLOWED IN THIS ZONE.

L.S. Figure 7. Cross section of typical plant grouping.

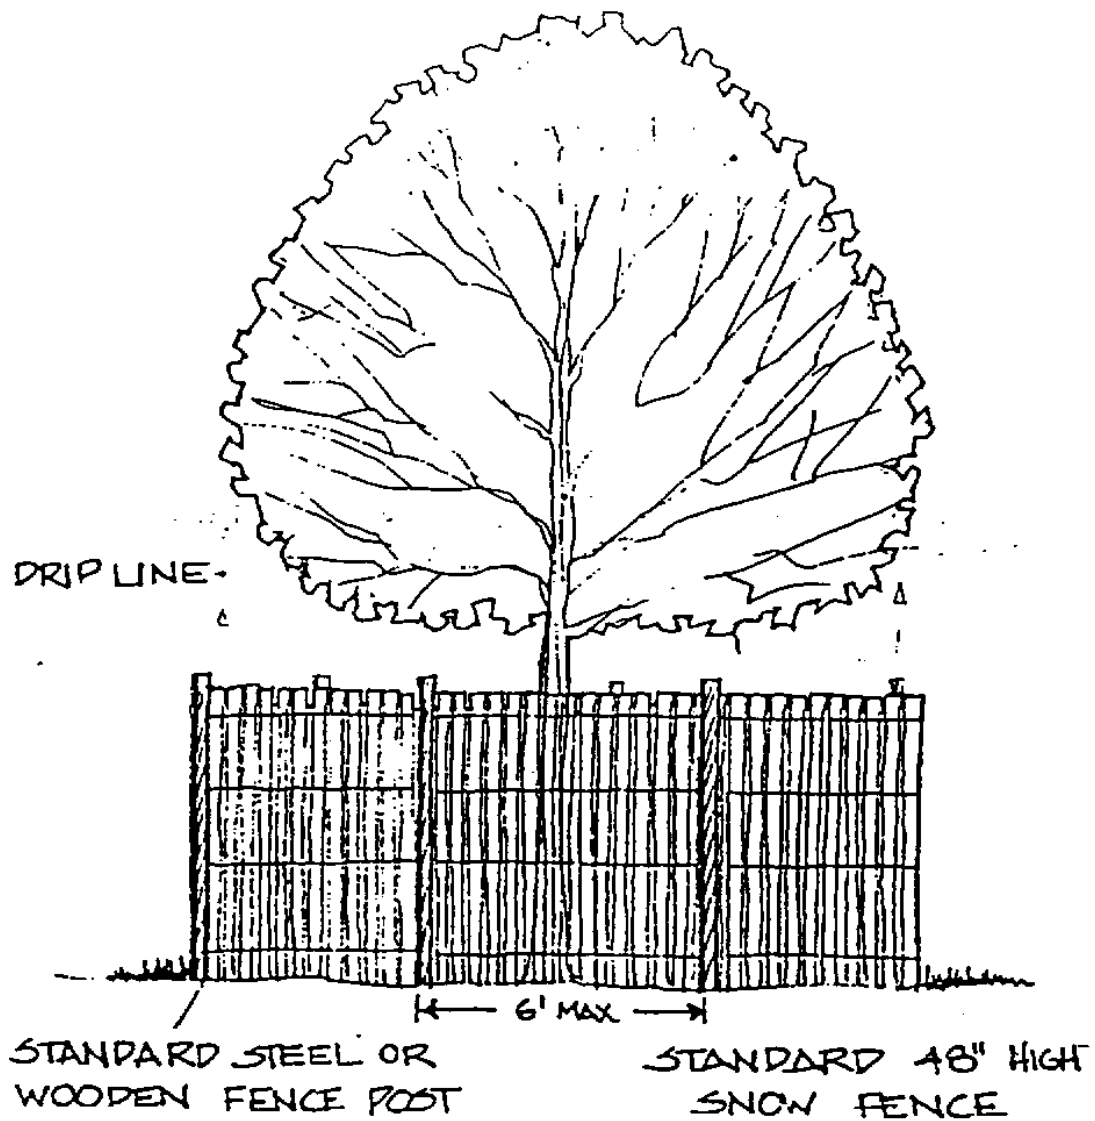
L.S. Figure 8. Existing tree protected by snow fence.
